Technical Bulletin

Bulletin No: TCH-003-042-A

Subject: BRAKE VALVE TREADLE REPLACEMENT – COACH APPLICATIONS

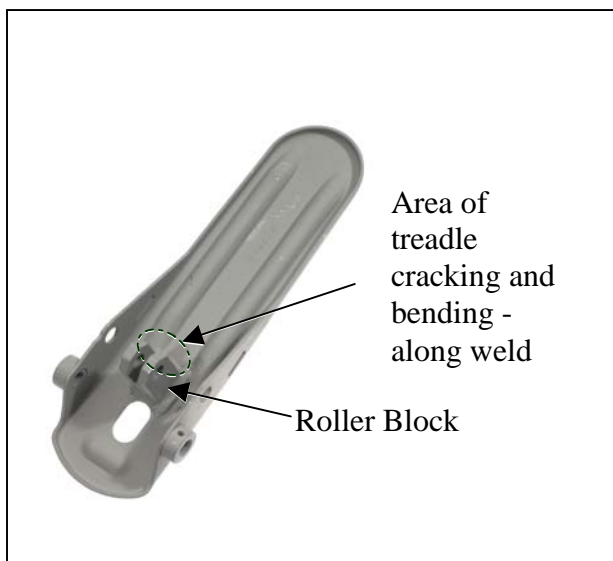
Figure 1 – Old Style Treadle

During normal use, some brake valve treadles may develop small cracks along the top surface, causing the brake valve treadle to bend. Over time this bend will result in a decreased treadle angle, which in turn will require an increase in braking effort by the vehicle operator. A quick visual inspection can identify if this condition is present.

This condition is limited to coach applications with a treadle configuration as shown in Figure 1. This unique treadle has a roller block welded to the middle of its underside. The cracking occurs near this weld.
