# Technical Bulletin

Bulletin No: TCH-008-037 Effective Date: 5/27/03 Cancels: NA

# Subject: AD-2 Product Recall Campaign

The Bendix AD-2 Air Dryer is a part of a voluntary recall campaign.

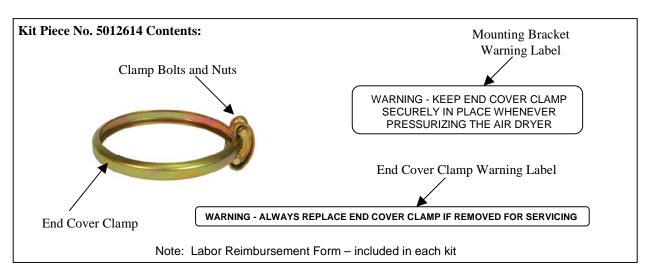
Date code located on side cover and/or on metal tag

Bendix will send owners/operators with the affected AD-2 a corrective repair kit at no charge. The kit contains a labor reimbursement form that must be completed and returned for reimbursement. Bendix will provide a reimbursement of \$10.00 (\$14.75 Canada) to cover labor necessary to install the kit. The AD-2 End Cover Clamp Modification kit can be installed without air dryer removal.

To request your AD-2 End Cover Clamp Modification kit (piece number 5012614) call Bendix Customer Service at our Huntington Indiana facility (see number above) and a representative will immediately place a no-charge order for you. The repair kit will contain detailed instructions to repair the product.
