# *Technical Bulletin*

Bulletin No.: PRO-09-11    Effective Date: 2/15/79    Page: 1 of 1

Subject: **FD-1 Fan Clutch Piston Revision**

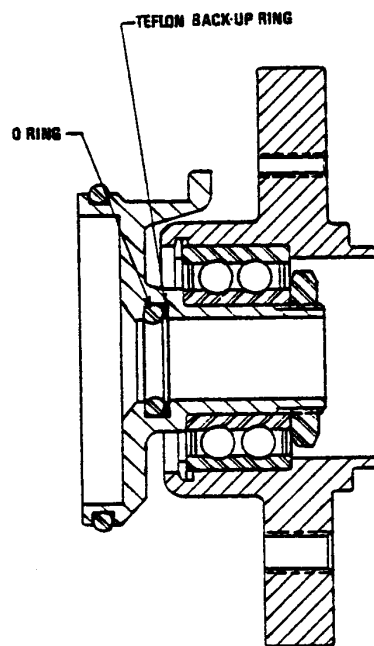
Effective January 18, 1979, a teflon back-up ring has been added to the inside bore of the FD-1 Fan Clutch piston. This change will allow the o-ring to seat against the teflon back-up ring rather than the metal surface.

The width of the piston o-ring groove has been increased to accommodate the teflon back-up ring; therefore, the teflon back-up ring cannot be used on the older revision piston.

The teflon back-up ring will be included in maintenance kits 288907 and 289319 so that the kits can be used to service both old and new revision pistons.
