# Technical Bulletin

Bulletin No.: PRO-20-07

Subject: **Ford F Series Truck Hydraulic Parking System HR-1 Hydraulic Relay Noise**

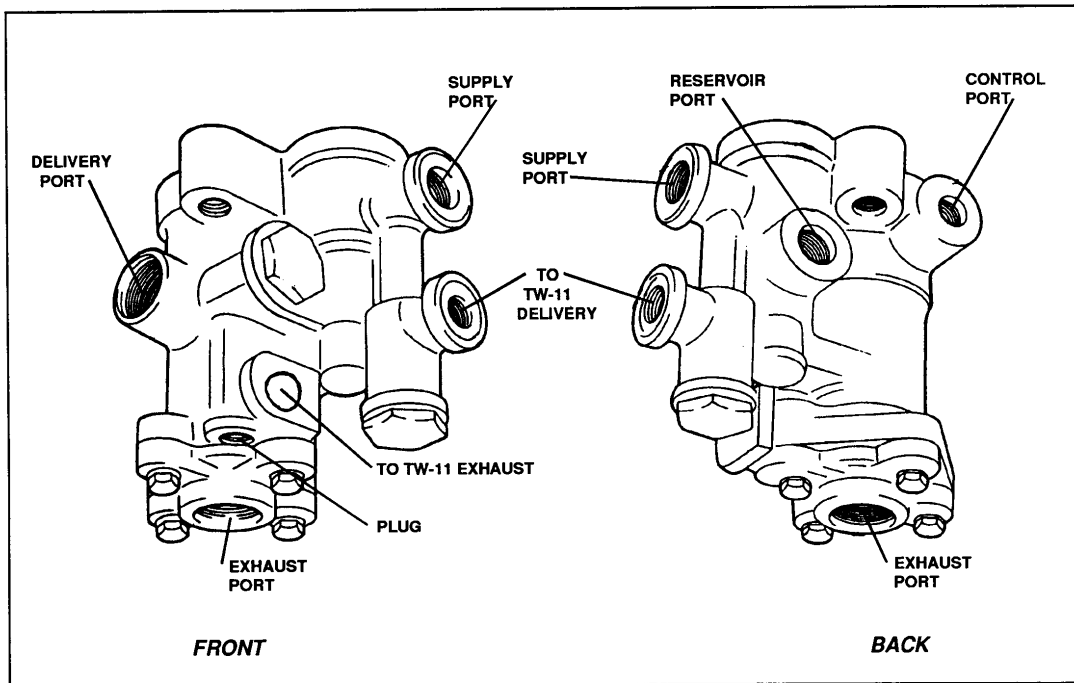
**HR-1 HYDRAULIC RELAY VALVE**

While some noise is inherent in the operation of a hydraulic brake system (pump, check valves and pressure regulating valves opening and closing) operators occasionally report hearing excessive noise emanating from the HR-1 hydraulic relay valve. The HR-1 is used on Ford truck model series 600, 700, 800, 900, 7000 and 8000. Described variously as a "buzzing, humming, popping or groaning" sound, the excessive noise is often attributed to a faulty HR-1. Because the HR-1 is mounted on the firewall, adjacent to the Hydro-Max booster, sounds are amplified. Excessive HR-1 noise can be the result of air in the parking brake system.

In order to eliminate the excessive HR-1 noise it is necessary to bleed the air from the spring brake actuators, using the vehicle manufacturer's recommended procedure. If the HR-1 noise is only temporarily eliminated and reappears in a short period of time, then it is likely that an external leak exists somewhere in the Hydro-Max and/or parking brake system which allows air to reenter the system. Check for fluid leakage and repair or replace as necessary.

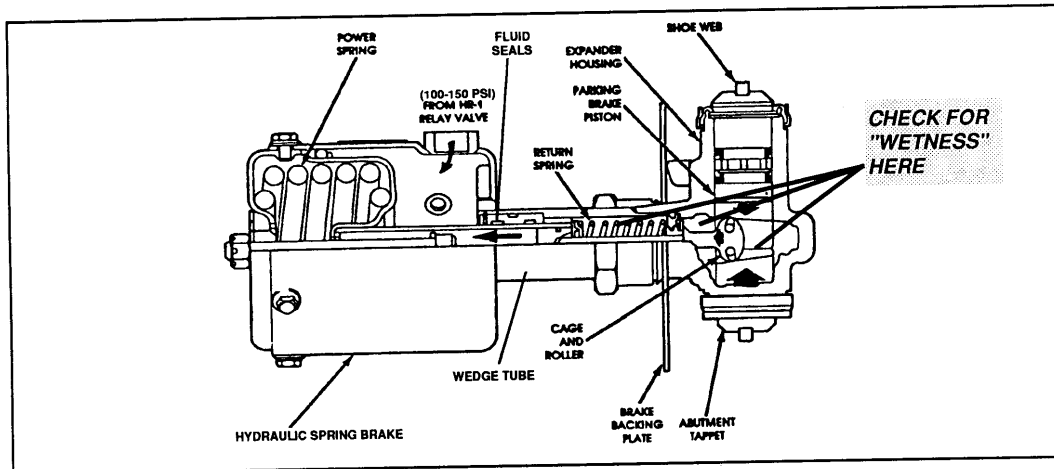
PARKING ACTUATOR WITH LUCAS GIRLING EXPANDER

Most fluid leaks can be found by visual inspection, however the spring brake actuators can LEAK INTERNALLY INTO THE EXPANDER unit of the Lucas Girling A2LS drum brake. Internal, hydraulic spring brake leakage can not be detected visually unless the actuator is removed from the expander and checked for "wetness" inside the wedge tube.

**CAUTION:** Thoroughly read the vehicle manufacturer's maintenance manual before attempting removal of the hydraulic spring brake actuators. A VERY HIGH SPRING LOAD IS USED AND INJURY CAN RESULT FROM IMPROPER HANDLING.
