Technical Bulletin

Bulletin No: TCH-002-014

Subject: **Bendix® Air Disc Brake Actuator Vent Hole Orientation**

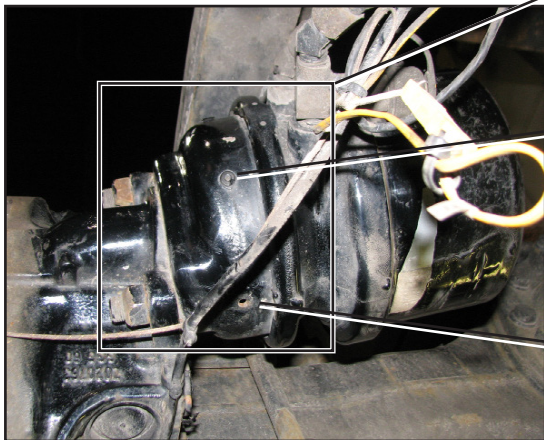
Air Disc Brake Actuator - Bottom View Shown

It has come to our attention that some Bendix® brand air disc brake actuators in service have the bottom vent hole plugged in error. This allows moisture and contaminants to enter, but not drain, causing corrosion and premature failure of the actuator.

Plugged Vent
(All other vent
holes may be
open or closed)

Open Vent
(Bottom vent hole
must be open)

Action: Vehicles with Bendix® brand air disc brake actuators should be inspected to verify that the vent hole closest to the bottom of the actuator is open. If a plug is found in this location, it must be removed to allow proper draining. The removed plug can be discarded. It is not necessary to place it in the other open port. Removal of the plug is easily completed by pulling it out with a pair of needle nose pliers. Note that the removal of this plug will not impact the actuator warranty.

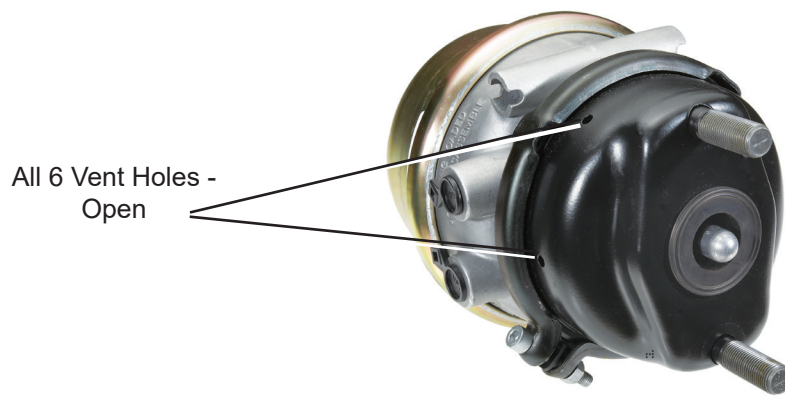
New OE and Aftermarket
Air Disc Brake Actuator Design

Since testing has shown that having more than one vent open does not impact either performance, or the life of the product, the plugs are being removed from all Bendix air disc brake actuator designs. This will eliminate the possibility of water and contaminants collecting in the actuators, reduce part numbers and inventories, and make servicing the actuators easier.
