Bendix® EverSure® with No Touch™ Power Spring Value Calculator

The Bendix® EverSure® Spring Brake with No Touch™ Power Spring Innovative, lighter weight design. Longer lasting performance.

Solution: Bendix® EverSure®

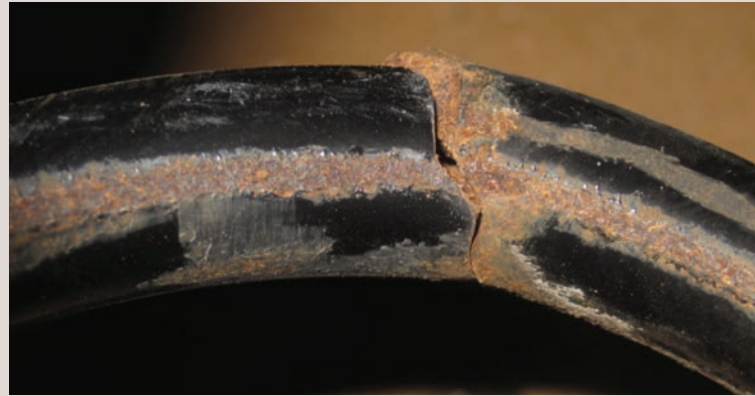
Problem: Broken Power Spring

A broken power spring is the leading cause of spring brake failure.

Most spring brakes have vent holes that are open to the environment. Many even have missing or loose dust plugs that create an opportunity for contamination to enter the spring housing. Due to the nature of this vulnerability, the power spring must be coated to protect it from possible corrosion. More often than not, **other suppliers' units suffer from "coil clash" which wears away this protective coating.** Without this layer of protection, the power spring can break. Once this happens, the broken power spring can often puncture the diaphragm, causing a leak to the unit. Even worse, this failure can go undetected and impact the parking performance of the vehicle.

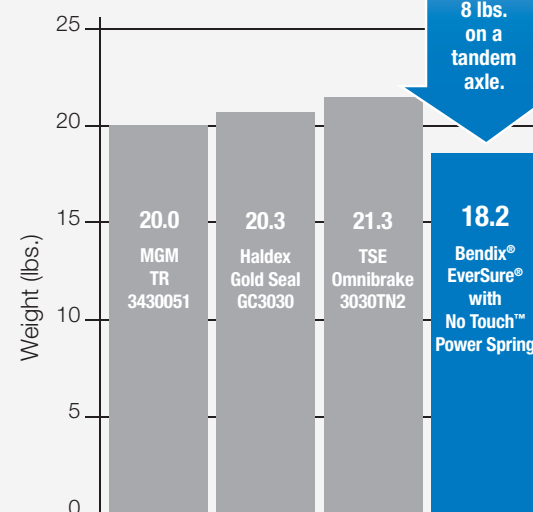
Lighter Weight with No Compromise

Savings of 8 lbs. on a tandem axle.

Comparison represents a Type 30/30 2.5" stroke chamber.
