# Technical Bulletin

Bulletin No.: PRO-20-07

Subject: **Ford F Series Truck Hydraulic Parking System HR-1 Hydraulic Relay Noise**

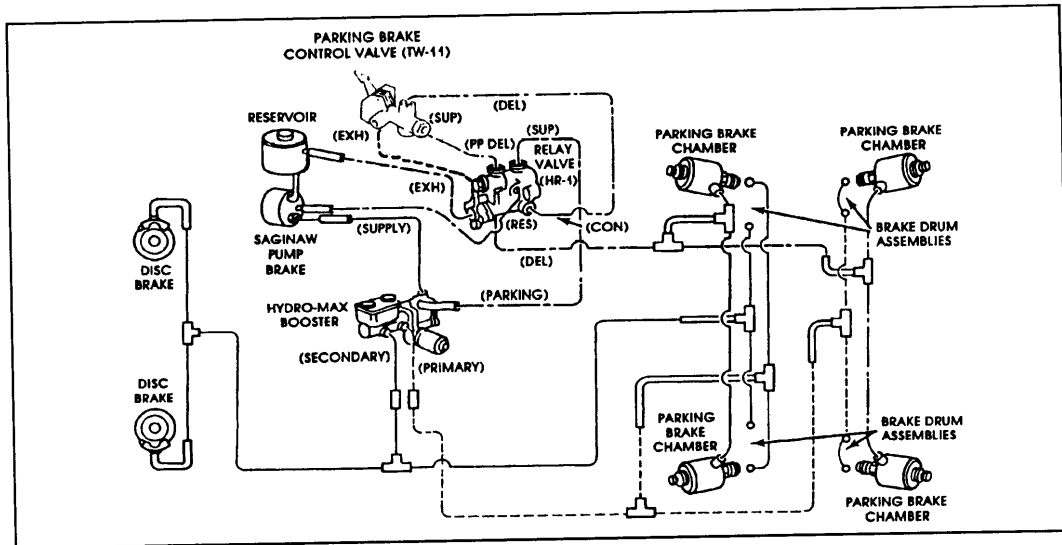
TYPICAL HR-1 SYSTEM

While some noise is inherent in the operation of a hydraulic brake system (pump, check valves and pressure regulating valves opening and closing) operators occasionally report hearing excessive noise emanating from the HR-1 hydraulic relay valve. The HR-1 is used on Ford truck model series 600, 700, 800, 900, 7000 and 8000. Described variously as a "buzzing, humming, popping or groaning" sound, the excessive noise is often attributed to a faulty HR-1. Because the HR-1 is mounted on the firewall, adjacent to the Hydro-Max booster, sounds are amplified. Excessive HR-1 noise can be the result of air in the parking brake system.

In order to eliminate the excessive HR-1 noise it is necessary to bleed the air from the spring brake actuators, using the vehicle manufacturer's recommended procedure. If the HR-1 noise is only temporarily eliminated and reappears in a short period of time, then it is likely that an external leak exists somewhere in the Hydro-Max and/or parking brake system which allows air to reenter the system. Check for fluid leakage and repair or replace as necessary.
